MONTANA LARGE APERTURE SEISMIC ARRAY

MONTANA LARGE APERTURE SEISMIC ARRAY
THIRD QUARTERLY TECHNICAL REPORT, PROJECT VT 2708

CONTRACT F33657-72-C-0390

1 JUNE 1972 - 31 August 1972

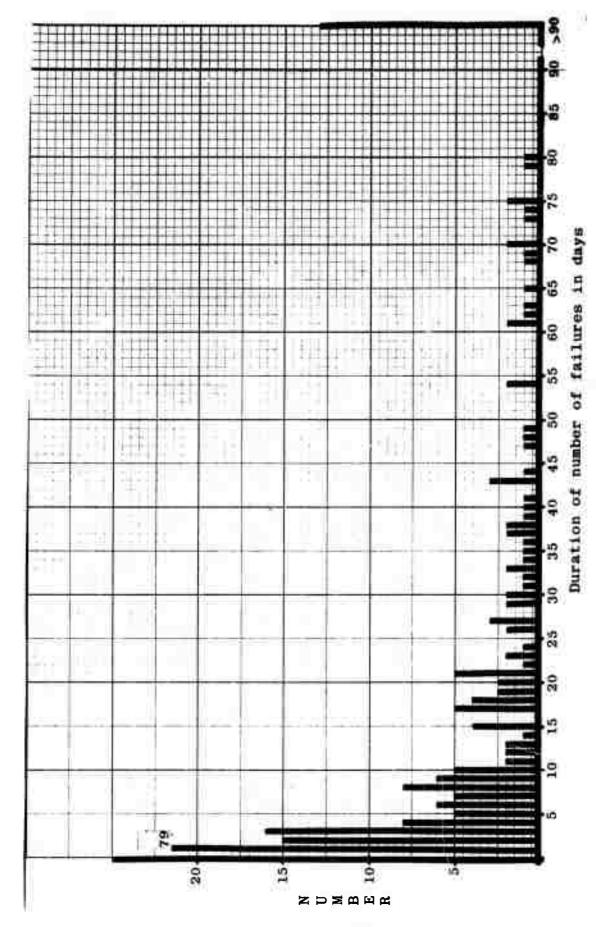
Distribution of the Number and Duration of the Defective SP Seismographs between 5 September 71 and 30 August 72 Figure 4.8

The performance of the SP array in terms of the number and duration of channel failures detected can be seen from the distribution shown in Figure 4.8.
